# UNDERWATER BRIDGE INSPECTION REPORT

STRUCTURE NO. 73534

CR NO. 111

SAUK RIVER

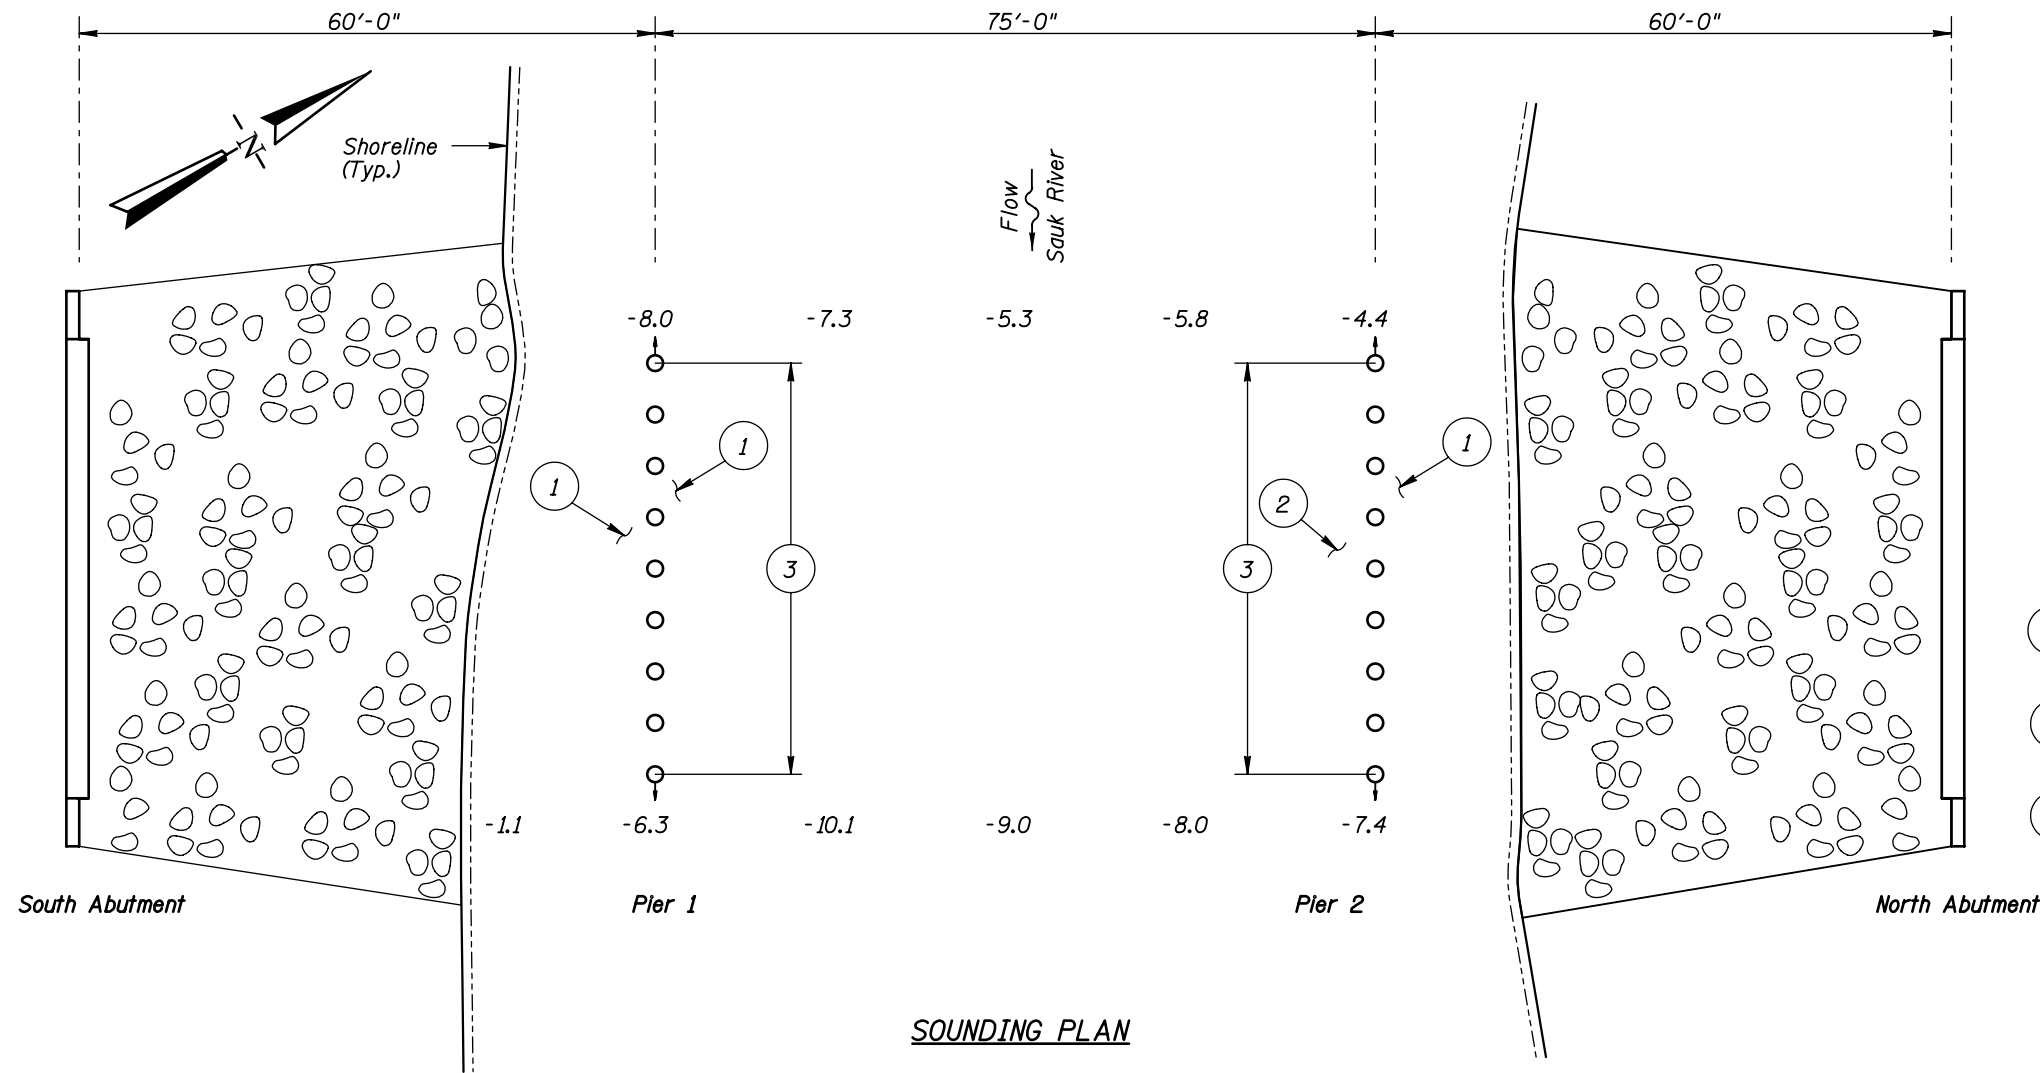
#### INSPECTION AND SOUNDING PLAN

- The channel bottom consisted of sand and silt with 1 to 2 foot diameter riprap and no probe rod penetration.
- The channel bottom consisted of sand and gravel with up to 4 inches of probe rod penetration.
- The steel piles exhibited coating failure and fairly uniform surface corrosion from 1 foot above the waterline to the channel bottom with random rust nodules up to 1/4 inch in diameter over 5 percent of the surface area.

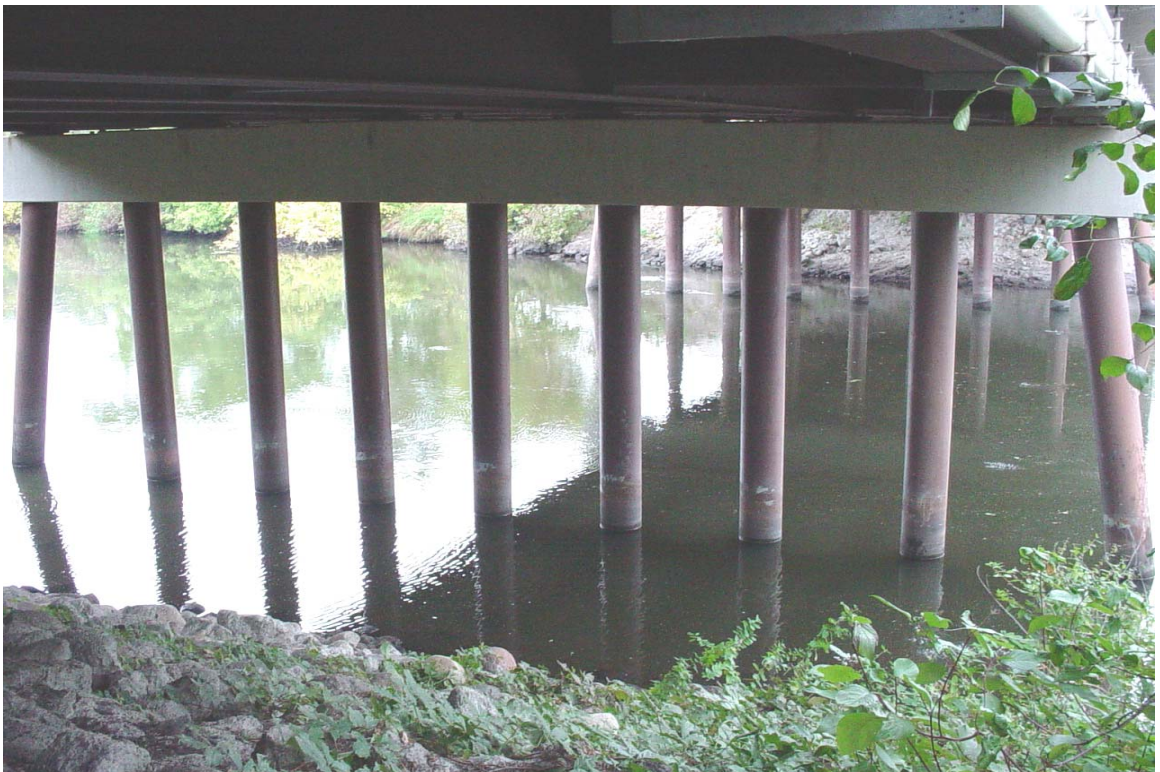
Photograph 2. View of Pier 1, Looking North.

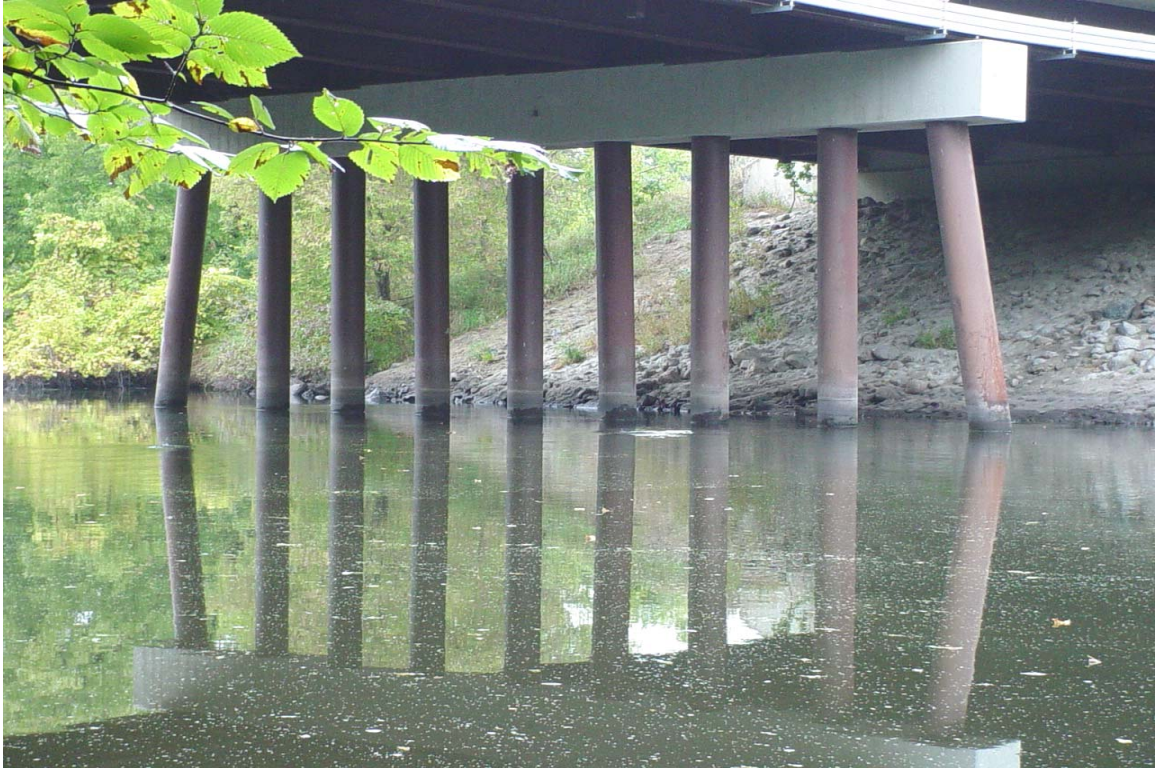
Photograph 3. View of Pier 2, Looking Northwest.
